PARAGLIDER ACCIDENT REPORT AND EXECUTIVE SUMMARY

Reference:	CA18/2/3/9792	
Paraglider Registration	N/A	Date of Accident	6 June 2019		Time of Accident	1200Z
Type of Aircraft	Paraglider APCO Fiesta		Type of Operation		Training (Part 141)	
Pilot-in-command Licence Type		Student Pilot (Paraglider)	Age	30	Licence Valid	Yes
Pilot-in-command Flying Experience		Total Flying Hours	3 Hours 28 Minutes		Hours on Type	3 Hours 28 Minutes
Last Point of Departure		Bulwer 1000 KwaZulu-Natal Province				
Next Point of Intended Landing		Bulwer 1000 KwaZulu-Natal Province				
Location of the accident site with reference to easily defined geographical points (GPS readings if possible)						
Bulwer at GPS South 29° 48' East 029° 45' at an elevation of 6036ft AMSL						
Meteorological Information		Surface wind: Less than 15 km/h, Temperature: 25°C, Visibility: Good				
Number of People On-board		1	No. of People Injured		0	No. of People Killed
Synopsis						
<p>On Thursday, 6 June 2019 at 1200Z, a paraglider student pilot took off from the mountain site Bulwer 1000 under the radio instruction of the chief flying instructor and take-off instructor. This was the student pilot's training flight to complete

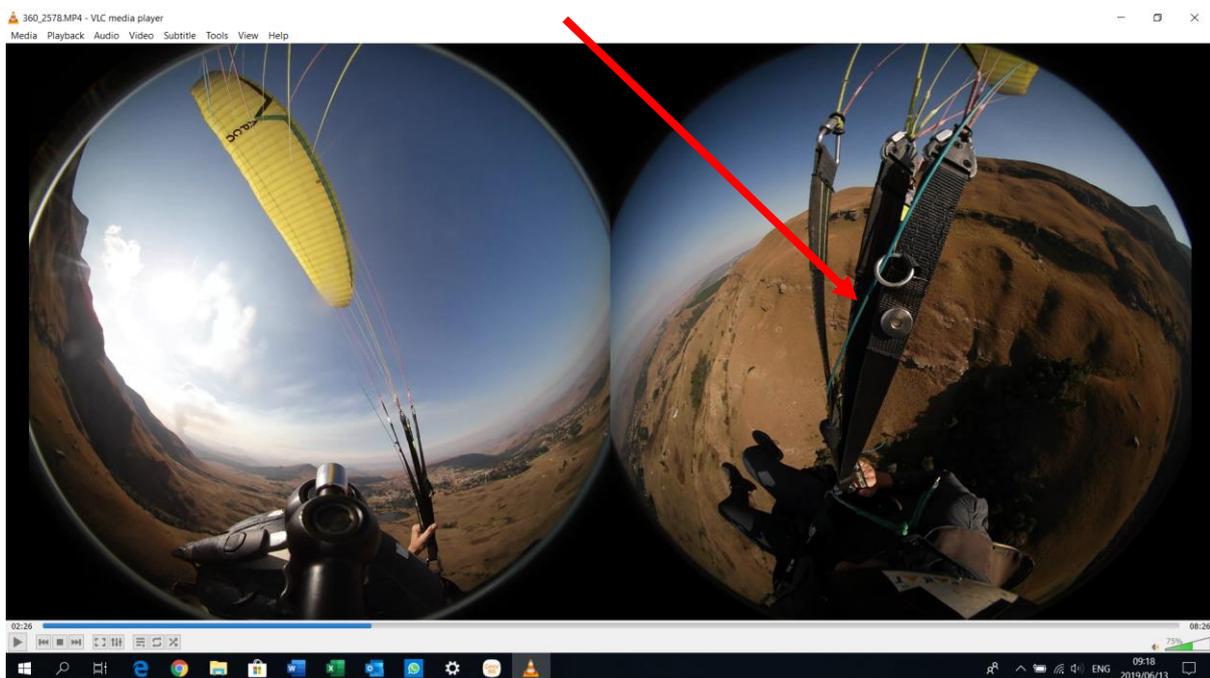
- 2.1.6 The student pilot had regularly and repeatedly held on to his risers, instead of having his brakes inhibited and free flowing to adjust to differing pressures. This resulted in the pilot gripping the risers and could not affect necessary brake input response as required when a deflation happened.

The student pilot was observed using limited weight shift and, therefore, excessive brake input to complete turns and thermal turns.

- 4.1 It is recommended to the operator that no camera must be mounted or added to helmets during ab initio training.
- 4.2 It is recommended that during the training exercises, instructors concentrate on accentuating weight shift with turns.

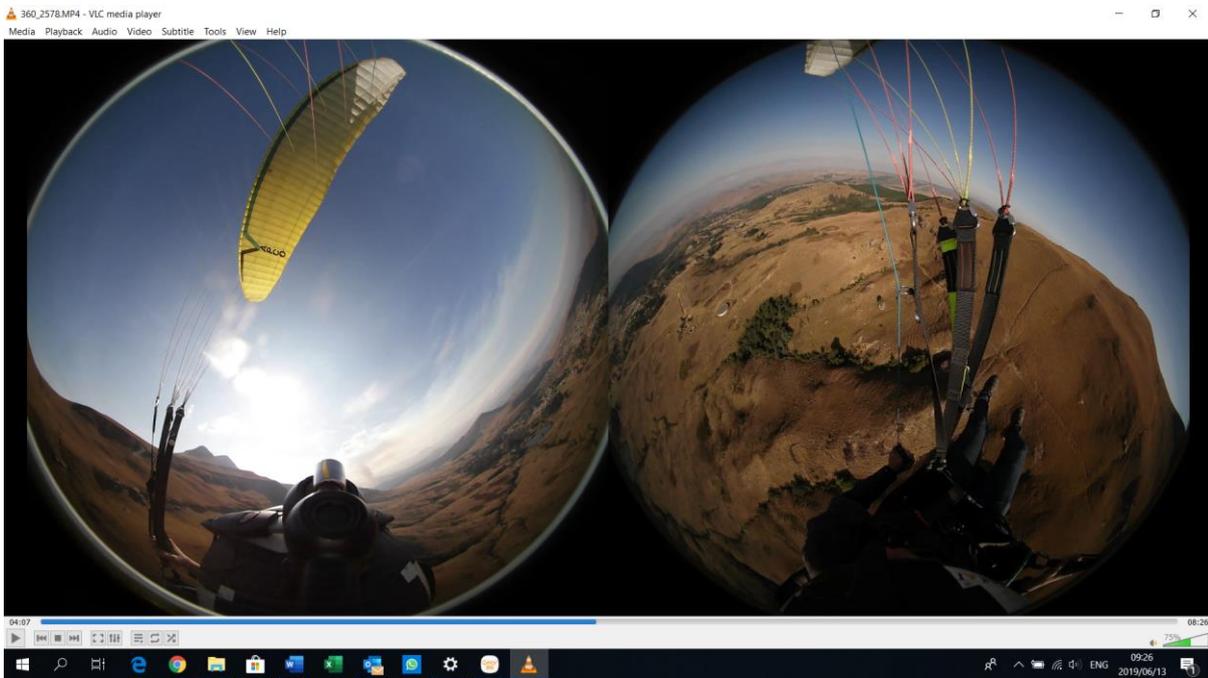
The pilot was flying with a more vertical body position to enable his camera to remain better aligned to the horizon, especially during turns.

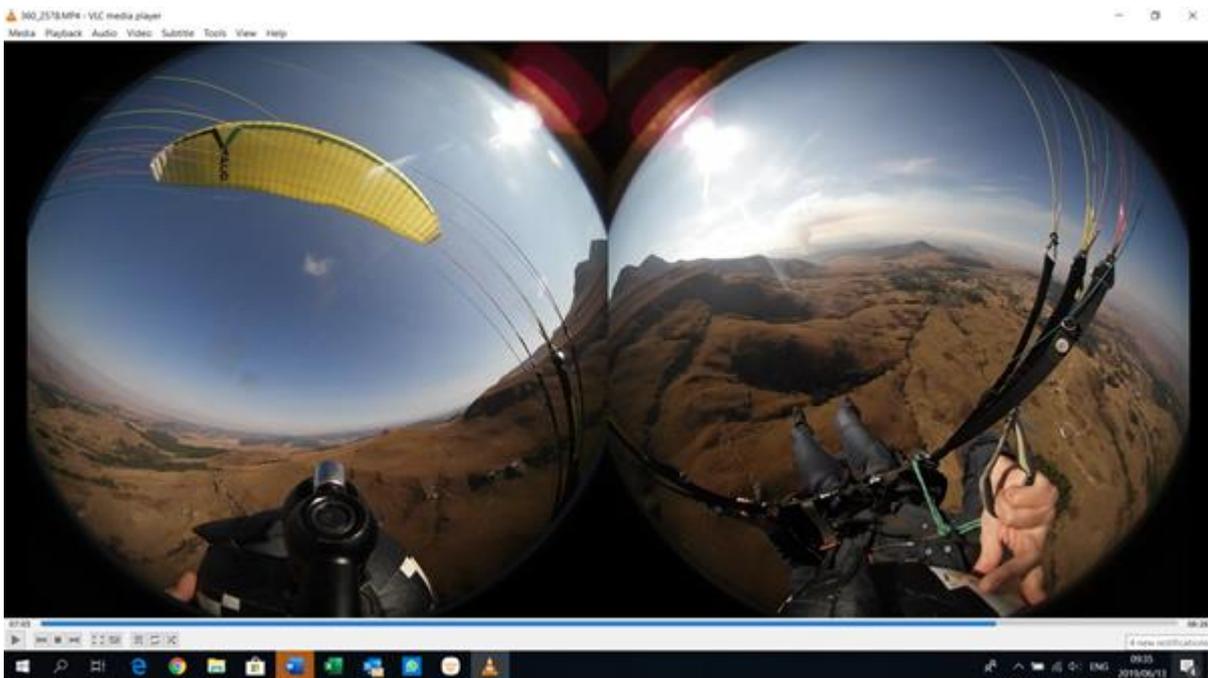
Demonstration of how the student pilot repeatedly held on to his risers.
